Shell Lake Dam Foundation Leak Repair

The City of Sand Springs, Oklahoma, identified a foundation leak in Bay 10 of the Shell Lake Dam, necessitating repairs to ensure the dam's structural integrity. The city's Public Works Department contracted with a qualified firm to address the issue, and Keithline Engineering Group was retained to provide engineering design and oversight for the project.

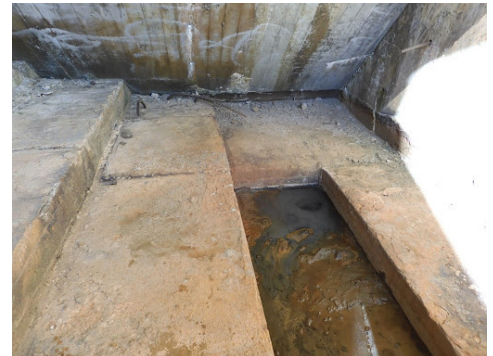
An inspection by Keithline Engineering revealed an active boil, or leak, in the concrete footing of Bay 10. The leak, measuring approximately 5" by 7", exhibited increasing water movement and was deemed a priority for repair. The engineering team determined that the water was likely traveling between the concrete footing and the porous sandstone underlayment before exiting through the hole in the concrete. This leak was transporting a small amount of material under low pressure. It was also determined the owner had made prior unsuccessful attempts to seal the area with bentonite.

After consulting with Alchatek, Keithline Engineering specified a leak-sealing solution centered around the injection of Spetec PUR H100. Alchatek recommended this hydrophobic polyurethane grout for its ability to expand and create a dense, impermeable seal upon contact with water. The repair strategy involved drilling through the concrete and injecting the grout into the concrete/sandstone interface to create a grout curtain. This approach aimed to stop the leak at its source and prevent further water migration.

1. Preparation:
 - Hammer-drilled 1/2-inch injection ports were installed into the concrete foundation at designated locations.
 - Saturated oakum rope or hydraulic cement was applied to temporarily plug the hole during the injection.
2. Injection Process:
 - Spetec PUR H100 was injected through installed packers using positive displacement pumps.
 - Injection proceeded until the grout formed a complete polyurethane barrier around the boil and stopped water infiltration.
 - The process included monitoring grout expansion and ensuring proper confinement within the concrete/sandstone interface.
3. Post-Sealing:
 - Following the injection, all nipples were removed, and drilled holes were patched with hydraulic cement to a minimum depth of 12 inches.

The injection grouting successfully sealed the foundation leak in Bay 10 of Shell Lake Dam. Spetec PUR H100 formed a durable polyurethane barrier, effectively stopping water flow and preventing further erosion of material from beneath the dam footing. The swift and effective repair was achieved in a matter of hours. Restek, Inc. precisely executed the specifications. The result is a solution that preserves the long-term structural integrity of the Shell Lake Dam, showcasing the value of proactive maintenance in preserving critical water resources.
