## CASE STUDY LEAK SEAL SLAB LIFTING

### Stopping Water Intrusion and Leveling Concrete

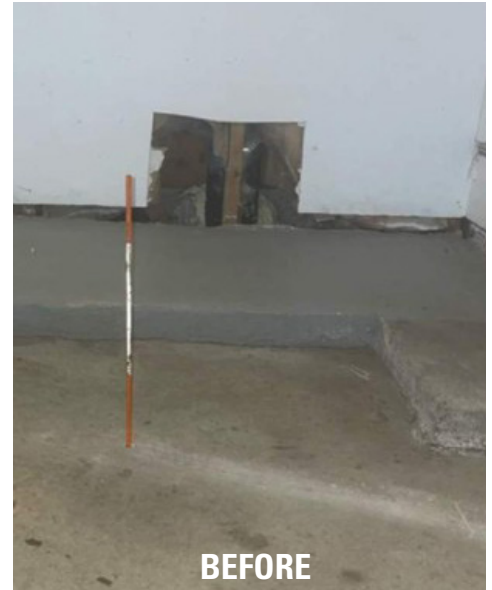
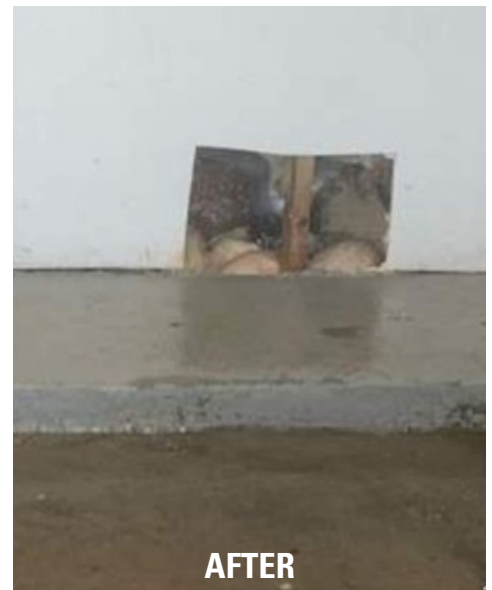
An infrastructure repair specialist was contracted to address a multifaceted water intrusion issue on a Rochester Hills, Michigan property. The basement had water ingress from both the furnace ductwork and the foundation. The ductwork, extending through the foundation wall into a garage-adjacent wall cavity, had sections below grade behind a garage curb. The root of the problem was water pooling under the back curb, caused by settled garage slabs from the main vehicle entrance.

1. Applied curtain grout to the positive side of the wall to stop water intrusion and encapsulate the dual wall furnace ductwork
2. Commenced void filling and leveling at the garage curb, progressing toward the main vehicle entrance
3. Filled all voids beneath the garage curb and leveled the concrete across all areas of concern
4. Conducted water tests to ensure all leaks were addressed before proceeding to phase two
5. Performed void filling and concrete leveling, displacing significant amounts of water near the main vehicle entrance
