## CASE STUDY DEEP LOCK®

# Verified Soil Improvement Beneath a Pool Shell

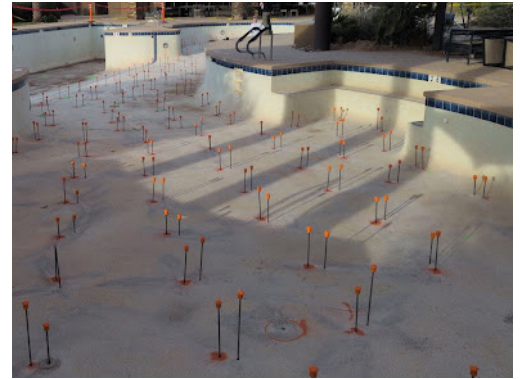
Cracks in a community pool shell were discharging water into the subgrade. The leak stripped fines from the upper three feet of soil, and the shell settled as bearing was lost beneath it. Patching the cracks alone would not have held, because the soil supporting the pool was still failing.

Penetrometer testing confirmed the loss. The cone advanced through the upper 2.6 feet without a recorded blow, and resistance stayed in single digits down to 3.6 feet. Below that, the profile firmed into competent sandy clay, reaching refusal at 9.5 feet. The design remedy called for scraping back two feet of subgrade and rebuilding it, a three-week job.

The contractor specified AP Lift 475 with the Deep Lock® process. The two-component polyurethane expands into weak soil and compacts it in place. Crews injected through rods driven from the surface, leaving the shell and deck undisturbed.

1. Logged baseline penetrometer readings to refusal
2. Laid out a 4-foot injection grid across 10,000 sq. ft. around the pool
3. Drove 900 injection rods and injected AP Lift 475
4. Injected a second level beneath the shell, compacting the soil between
5. Re-tested the profile against baseline

- Restored bearing in the eroded upper three feet, where cumulative blow counts rose from 2 to 101
- Increased cumulative resistance 139% through the upper 6.6 feet, with values below that depth unchanged
- Stabilized 10,000 sq ft to a treated depth of 10ft
- Eliminated the two-foot scrape and rebuild
- Completed in two days against the three-week estimate
