## CASE STUDY LEAK SEAL

### Below-Grade Tunnel Leak Remediation

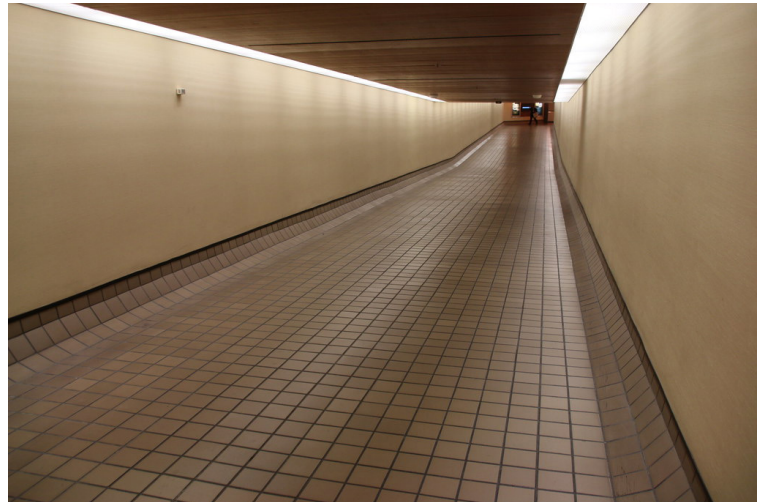
Visual inspection confirmed that water was entering through the wall/flashing joint and migrating into the tunnel ceiling. The stains and moisture patterns suggested a continuous leak path exacerbated by negative hydrostatic pressure. The location and nature of the leak made traditional surface repairs ineffective, as water was entering from behind the structure and not from an exposed face.

Alchatek recommended injecting the joint between the tunnel shell and the building wall with Spetec PUR F400, a hydrophobic polyurethane grout. This product was chosen for its ability to react with water and expand, effectively sealing active leaks even under negative pressure. The material's low viscosity allows it to penetrate tight joints and bond with both concrete and steel, creating a durable, watertight seal. The recommended installation method involved using a Titan 440 electric injection pump, ensuring the grout was injected until the joint could no longer accept any more material.

1. The team identified the leaking joint at the wall/flashing interface as the primary injection target.
2. Injection ports were installed along the joint to provide access for the polyurethane grout.
3. Spetec PUR F400 was injected using an electric injection pump, with technicians monitoring for material refusal and observing for any signs of milky fluid or foam, which indicated grout migration.
4. Injection continued until the joint was fully saturated and would not accept additional material, ensuring complete sealing of the leak path.
5. The process required no pre-pumping or removal of water from the joint, as the hydrophobic grout was designed to react in wet conditions.
