CASE STUDY  
LEAK SEAL

### Sealing Residential Basement Leaks in Alaska

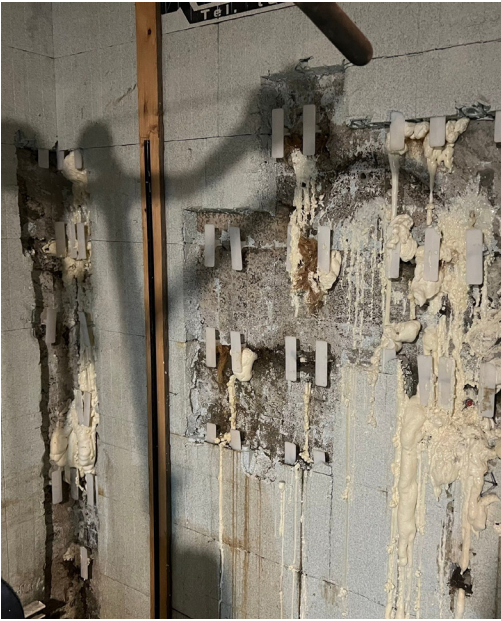
SPETEC® PUR HIGHFOAMER Uncured (Appearance brown liquid)		
Viscosity at 77°F (25°C)	(ASTM D4878-98)	± 215 cP (± 215 mPa.s)
Density	(ASTM D3505-96 [2000])	± 65.9 lbs/ft³ (± 1.12 kg/dm³)

After conducting a thorough inspection, the crew found issues with the membrane around the perimeter of the house and proposed injecting Alchemy-Spetec’s Spetec PUR Highfoamer into the walls to make up for the weakly consolidated concrete and seal the leaks. This durable polyurethane was perfect for this job due to its low cost and high expansion rate.
