Active Rail Bridge Pier Stabilization

A cracked granite pier supporting an active freight rail line moved approximately ¼ inch every time a train crossed. With the Hudson River below and rail service still running, continued movement created a serious structural and operational risk.

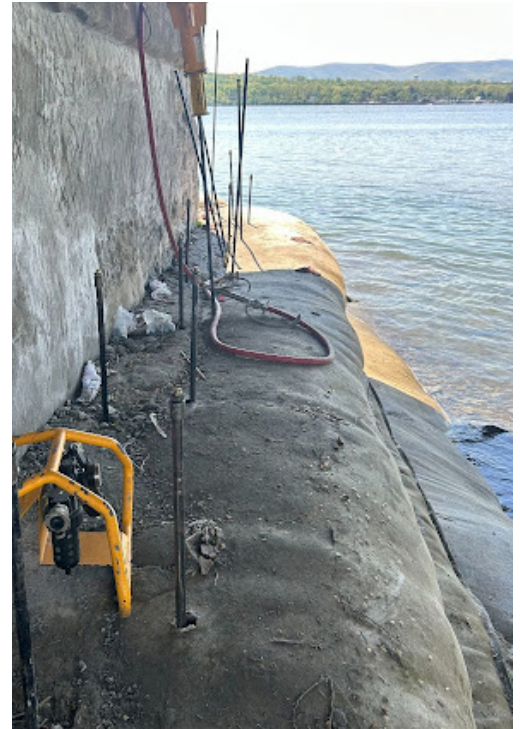
The planned carbon fiber wrap required a stable substrate before epoxy work could proceed. Active pier movement prevented warranty approval, while existing grout bags, riprap, and rail operations blocked excavation or underpinning options.

A geotech contractor selected **AP Lift 430** with the Deep Lock® process to stabilize soils beneath the pier while trains stayed active. The polyurethane foam was chosen for deep injection, fast reaction, void filling, and support below difficult access zones.

1. Laid out offset injection pattern around pier base
2. Rock-drilled through grout bags and obstruction zones
3. Installed 36 injection pipes: 18 to -10 ft and 18 to -5 ft
4. Injected 35 lb at deep points and 25 lb at shallow points
5. Pumped approximately 150 gal total
6. Monitored crack movement during train loading
7. Stopped injection when lift indicated full contact

- Reduced crack movement to a minimum
- Stabilized the pier for epoxy repair and carbon fiber wrap
- Kept freight rail active during stabilization
- Avoided excavation and underpinning disruption
- Completed stabilization in two injection visits
