CASE STUDY LEAK SEAL

Emergency Leak Repair at Lift Station

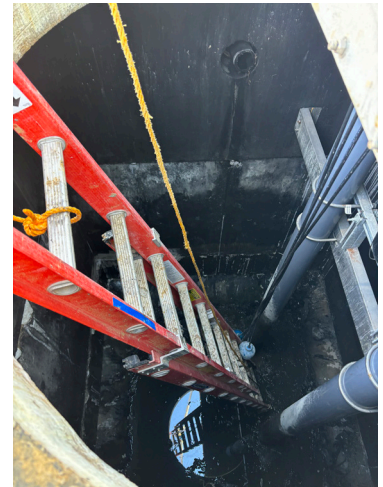
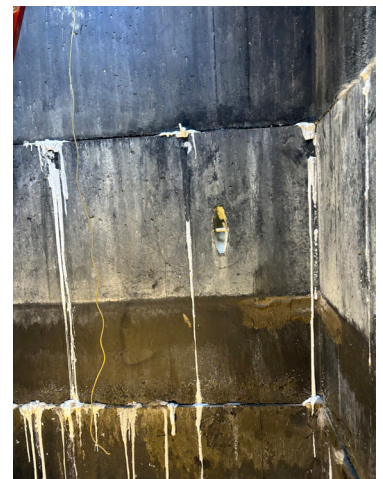
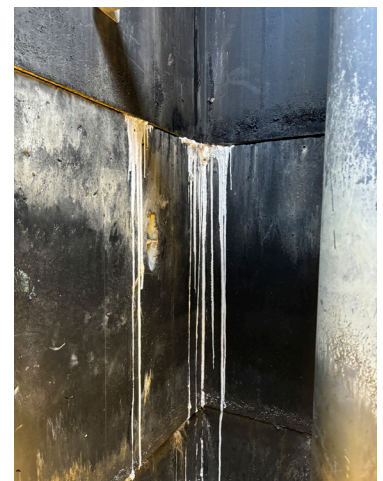
- Structural weaknesses detected in multiple joint locations
- Massive water loss occurring within 24 hours of installation
- Thousands of gallons of water escaping through compromised joints
- Environmental concerns due to uncontrolled water discharge

1. Complete dewatering of the lift station
2. Technical team rappelled into the structure
3. Systematic injection of Spetec F400 at all compromised joints
4. Progressive sealing to ensure complete joint stabilization
