Lifting Sunken Steps at a Mixed Use Complex

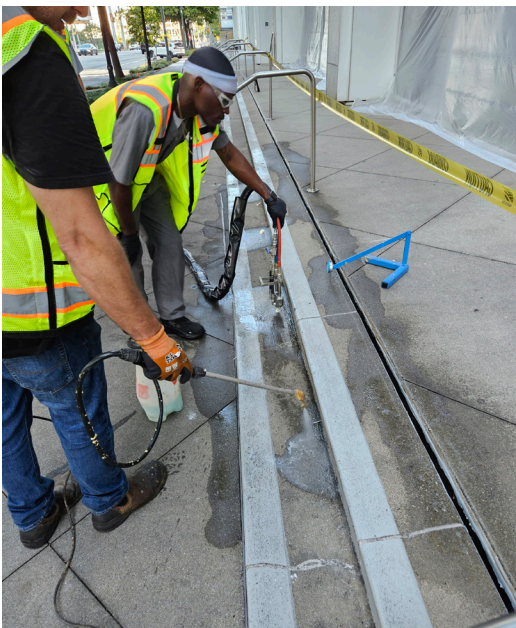
A concrete staircase in a prominent mixed-use complex in Atlanta needed urgent repairs due to a set of 75-foot-long sunken steps. This issue posed a significant trip hazard, potentially compromising visitor safety. The problem stemmed from a combination of factors working together over time. Water infiltration through expansion cracks had created voids beneath the stairs, weakening their foundation. Compounding this issue was the natural tendency of separate concrete pieces to expand and contract, moving independently from each other. This movement was particularly problematic as it caused the steps to separate from the adjacent sidewalk. Over time, the repeated cycles of expansion and contraction, coupled with the underlying voids, led to the steps sinking and rolling, creating a hazardous situation.

AP Lift 430 was selected as the repair material for this restoration project. This polyurethane foam has expansive properties that are suitable for lifting sunken structures. Once cured, AP Lift 430 provides support for long-term stability, aligning with the project's requirements.

The repair process began with an assessment of the trip hazard. This allowed the team to determine the extent of the problem and plan their approach. Next, backer rods between the steps and sidewalk were removed to prepare the area for treatment. Alchatek Surface Guard 125 was applied around the injection area to prevent any excess polyurethane from bonding to the concrete. Protective sheets were placed to shield nearby glass surfaces.

The team drilled holes through the 8-inch concrete steps to reach the underlying soil. Soil probes revealed firm underlying conditions. The team then implemented their injection strategy. They created an initial foam layer slowly, injecting it just once every ten seconds. This gradual approach prevented existing hairline cracks from expanding during the lifting process. The team continued to inject AP Lift 430 until the steps were level. Finally, they redrilled and applied a second injection layer beneath the first to fill any voids created in the process. New backer rods were then installed.

To enhance the longevity of the repair, the team took an additional crucial step. They sealed the expansion joints with silicone, creating an optimal water barrier. This silicone sealant is flexible, accommodating future expansion and contraction. This extra measure was designed to protect the structure from water infiltration and movement, addressing the root causes of the original problem.

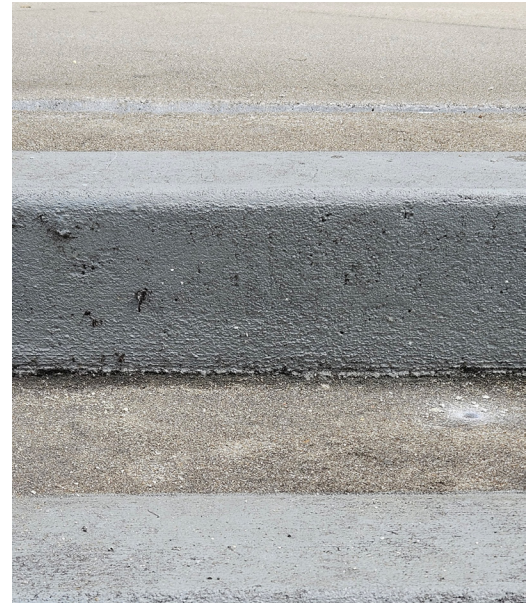
In just four hours, the steps were restored to a level position, aligning with the adjacent walkway. This efficient repair method addressed the immediate safety issue while extending the structure's lifespan. By lifting the existing steps rather than replacing them, the property owner avoided substantial expenses associated with demolition, new materials, and extended labor time for a complete replacement. This approach ultimately provided significant cost savings.
