Repairing a Footing in a Detention Pond

Powerful Polymers

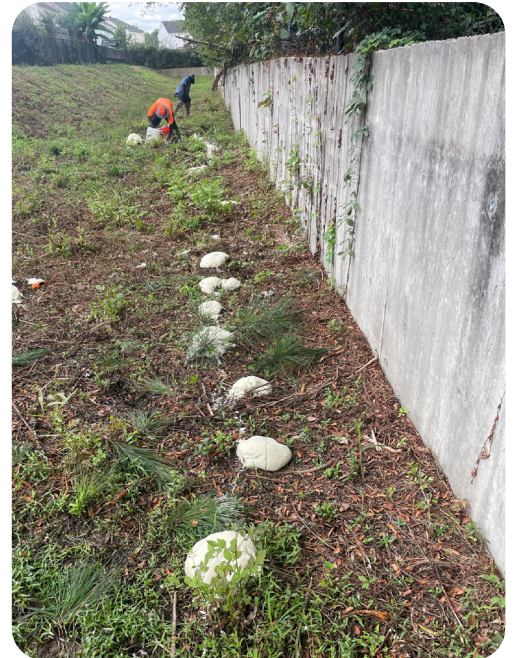
A general contractor working with a homeowners association reached out to a specialty contractor about a detention pond wall that was leaking along the footer in several places. A detention pond is designed to collect rainwater and then let it drain slowly in a controlled manner. But in this case, water was washing out quickly in an uncontrolled manner in multiple spots under the footing.

To rapidly address the problem the contractor chose AP Fill 720. This single component, closed cell, hydrophobic, water-reactive, solvent and phthalate-free, low viscosity polyurethane foam has a high expansion rate, and is ideal for filling voids. In this case, AP Fill 720 was the perfect choice for filling the soil voids underneath the footer created by water erosion.

First, the crew injected AP Fill 720 along 150 feet of the wall, installing approximately one gallon underneath the footing every two feet. Next, they installed another 75 gallons spot treating larger voids.
