## Eroding Soil Could Lead to Cave In Underneath Busy Intersection

County inspectors found a depression in the road due to an underground sewer line that wasn't sealed at a heavily trafficked roadway intersection in Orange County, Florida. Water and eroding soil were infiltrating the sewer line causing the road to slowly settle. The resulting voids around the drainage structures had the potential to grow larger, eventually resulting in a complete cave-in of the roadway. In this particular case, there was a patch of asphalt 12' x 25' that was settling and officials feared a cave-in would occur. A point repair was done from within the leaky pipe to stop the infiltration but they feared it was only a matter of time before the road gave way. It was going to be very difficult and inconvenient to dig up this roadway, fill the void, re-compact, and re-pave due to the high volume of traffic, the adjoining rail crossing, as well as several major utilities running through the area. Not to mention that the area would have to be completely shut down to accommodate all of the equipment required for such a repair.

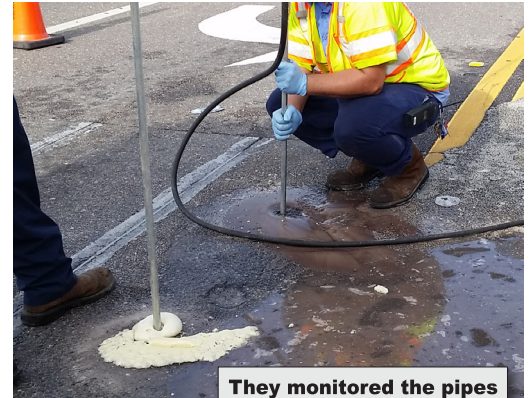
**They monitored the pipes while injecting material at a rate of 2 gallons per vertical foot through the open manhole to identify additional leaks that had been missed during the first point repair.**

**As expected when foam was observed coming in through a leaking joint it quickly sealed off the leak at the same time it was stabilizing the soil.**

We advised their crew to lay out a grid on the settling asphalt area and set up injection points to drive pipes down to the 13' depth where leaking had occurred and where the loose soil zone was located. They monitored the pipes while injecting material at a rate of 2 gallons per vertical foot through the open manhole to identify additional leaks that had been missed during the first point repair. As expected when foam was observed coming in through a leaking joint it quickly sealed off the leak at the same time it was stabilizing the soil.
