Stabilizing a Foundation to Save a Valuable Two Story House

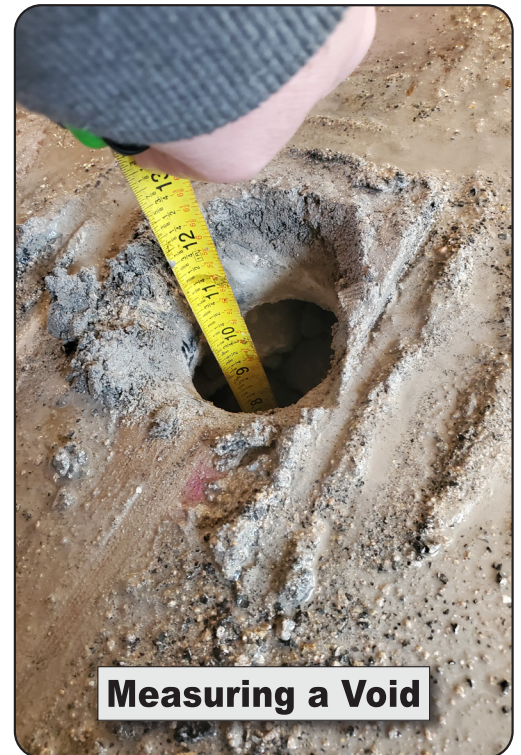
The crew used Alchemy-Spetec's AP Fill 700 high-strength soil stabilization grout to solidify the four feet of poorly compacted soil beneath the foundation. This polyurethane resin was the ideal choice because of its ability to thoroughly permeate the soil and then cure to an incredibly high compressive strength. They used Alchemy-Spetec's PolyShark grout pump to install the material. This pump is specifically designed for large-scale soil stabilization jobs.

The crew used a Geoprobe pipe driver to insert grout injection pipes four feet deep into the supporting soil around the house. AP Fill 700 was then injected to stabilize the soil. They also used a carbide drill bit to create small 3/8" drill holes in the concrete foundation slab in a diamond pattern, 4 feet on center. After each drill hole was created, the crew inserted a pipe through the slab and into the ground, pumping the grout to stabilize the soil and fill the voids.
