Tunnel Crack Repair with Expanding Grout

Case Study - Tunnel Crack Repair with Expanding Grout

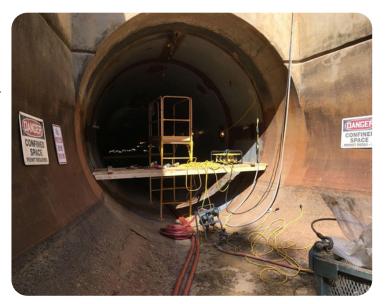
Visual inspection and on-site review identified the leak path at the interface between the concrete and metal. The crack width was measured between 0.2 and 0.3 mm, indicating that traditional cementitious grouts or surface sealants would not be effective. The challenge was to deliver a material that could penetrate deep into the joint and expand to form a watertight seal, even in confined spaces and around embedded metal.

Alchatek recommended Spetec PUR F400, a low-viscosity, hydrophobic polyurethane grout. Its ability to penetrate narrow cracks and react with water creates a durable, flexible seal. The product's flow characteristics made it ideal for tight joints, and its expansive properties ensured comprehensive coverage within the voids and cracks. The injection plan called for drilling at the locations marked on the provided site photos, angling back toward the metal at approximately 18 inches deep to intersect the leak path.

- 1. Identified injection points along the crack, using red-dot markings on the structure as a guide.
- 2. Drilled holes at 45° angle 12-inches apart, reaching approximately 18 inches deep to intersect the metal interface.
- 3. Injected Spetec PUR F400 polyurethane grout through the drilled ports, using a pump setup suitable for low-viscosity materials.
- 4. Monitored for material refusal and evidence of grout migration to ensure the joint was fully saturated and sealed.
- 5. Continued injection until the crack would not accept additional material, confirming a complete watertight barrier.
